## Salt Survey Comparison of And Pressurized vs Ambient Deck Air Intakes on JEFF (B) Hovercraft

R. E. RUSKIN

February 2, 1981

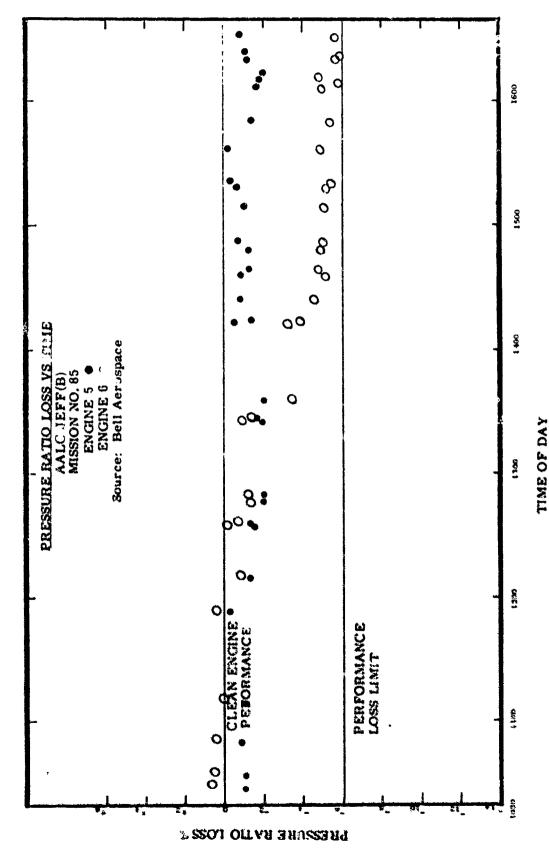
This same pattern is evident in the engine degradation data. In columns 2.3. and 4 of Table III are tabulated the engine degradation measured by the loss in the ratio between the intake pressure and discharge pressure of the compressor. In column 3 the loss rate in percent per hour is shown for mission 085 averaging the degradation over the entire 6.3-hour duration of the mission. Since approximately half of this mission was spent at idle while changing probes for the salt survey, the total air ingested in the engines was reduced to the equivalent of a 4.7-hour running time. The total degradations for the mission divided by 4.7 hours are shown in column 4. Since the degradation in No. 6 engine was probably as great or greater during the idle periods than during the running time, the 6.3-hour values probably should be used for No. 6 engine, where is engines 1 thru 5 had little degradation during these idle periods so that the values in the 4.7-hour column should probably be used for engines 1 thru 5. On this basis, the ratio of degradation for No. 6 engine to that for No. 5 would be approximately a factor of 10 rather than the factor of 14 as shown in Table III. This ratio of ten, possibly fortuitously, is approximately equal to the ratios of the salt ingested as shown in columns 6 and 7. Engine degradation during the other missions (078-084) in which No. 6 engine was pressurized are shown in column 2 of Table III. These values indicate that for those missions in which there were not repeated setdowns for probe changes (as was the case in mission 085) the degradation in engine No. 6 was only 70% higher than that for the average of engines 1 thru 5. This small difference could well be accounted for solely by the fact that No. 6 engine with its pressurization "boiler plate" could not accomodate a second stage agglomerator filter as was used in engines 1 thru 5. See Appendix D for filter arrangements. Two possible explanations for the considerably greater degradation of No. 6 engine on mission O85 are (a) that more spray is ingested into the lift fan outboard inlet at low speeds as compared to that at higher speeds, therefore causing a greater average ingestion into the fans and to the pressurized duct of No. 6 engine on this mission; or (b) the fact that when the craft settles down in the water during idle, water floods the bag plenum where air is blowing back to the pressurization duct for No. 6 engine. During lift off, when the fan speeds are increased to raise the craft, this air velocity becomes quite high both blowing downward onto the water in the bag immediately under the lift fan and also blowing along the length of this water surface until this water has time to drain out. In Figure 7 the engine degradation for engines No. 5 and No. 6 are shown throughout mission 085. Here it can be noted that the greatest degradation in engine No. 6 occurred at approximately 1330. Referring back to Table I it should be noted that at approximately a is time the ingested sait at the engine belimouth in column 11 indicates that this is the first period in which the PPN ingested into engine No. 6 exceeded the value of 0.1 PPM which the original AVCO engine data indicated was the transition loading for considerably increased degradation of the engine.

Fig. 7. Chronological Plot of Engine Nos. 5 and 6 Degradation during Mission 85. Note No. 6 Fall-off at 1337h when Salt Loading Exceeded 0.14 ppm.

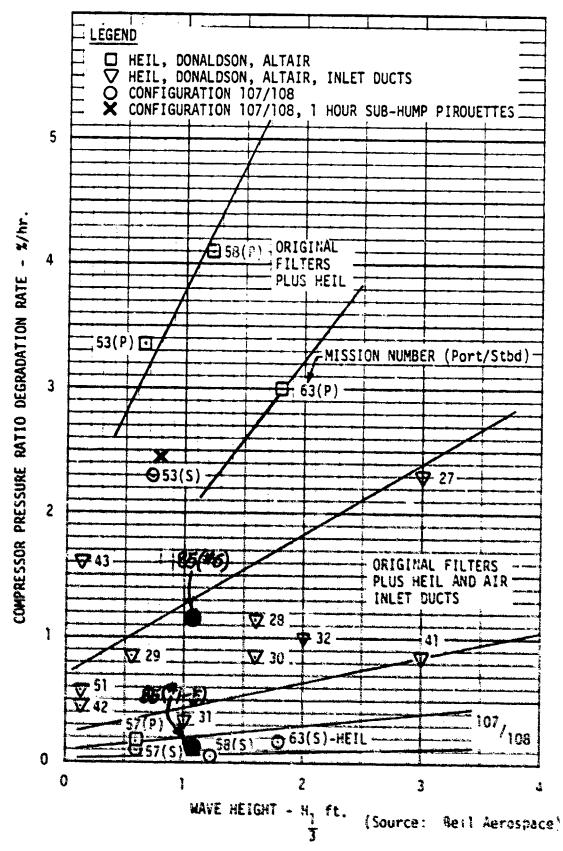
This factor of 20 improvement in leakage from 1978 to the present tests is corroborated by the same factor of 20 improvement in the engine degradation between the 1978 missions and recent ones, as shown in Figure 8. In this figure it can be seen that the original filters cause a degradation rate of approximate 2 1/2 to 3% per hour. The addition of air inlet duct sheds improved this by approximately a factor of 4. The bottom curves labeled 107/198 show approximately 0.1% per hour degradation rate. While it can be argued that this improvement is due to the improved filters in the 107/108 configuration, it should be noted that during mission OS) the port side of the craft was still using essentially the original base line type of filters on engines 2 and 4. The variation among the engines, probably from leakage, was sufficient to mask any improvement on the starboard side using configuration 107/108 as compared to the port side with the nearly basic filter configuration. This variation is apparent both in the engine wash water salinity data and in engine degradation data taken on recent rissions (978-085). Whereas the forward engines 1 and 2 are expected to be generally cleaner than the aft engines. Table I' shows that on mission 085 on the starboard side the forward engines I and I were dirtier than the aft engine No. 5. Likewise, on the port side the forward engine 2 was dirtier than 4. Both port engines 2 and 4 (using essentially the original base line configuration of filters) were cleaner than the corresponding starboard engines with the

Fig. 8. JEFF (B) History of Compressor Degradation. Engine No. 6 Pressurized vs Nos. 1-5 Unpressurized on Mission 85 Shown as Solid Circles.

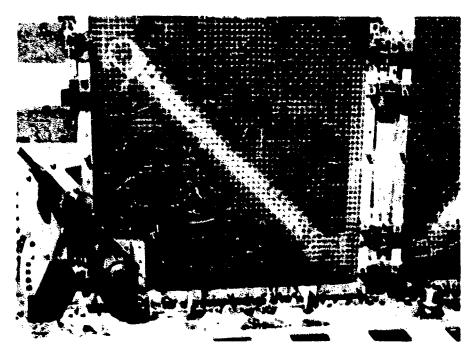
Fig. 10. Vegetation Debris Collected on Lift Fan Screens.
